# Leader Impression i10A-LE Speakers Replacement

This repair guide is for the Leader Impression i10A-LE speaker replacement. This replacement will take 15 minutes to complete.

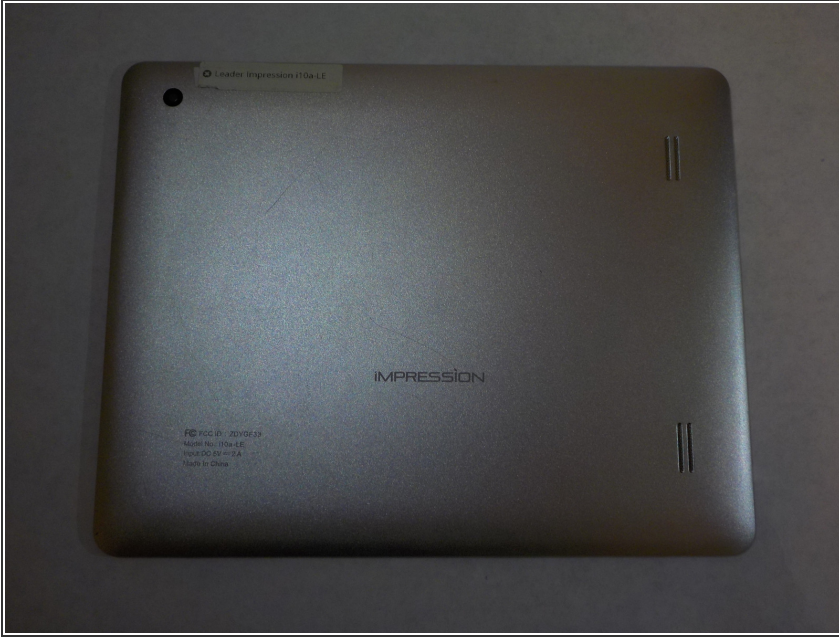
## Step 1 — Speakers

- Start with your Leader Impression i10A-LE with the word "Impression" closest to you and the camera in the top left corner.

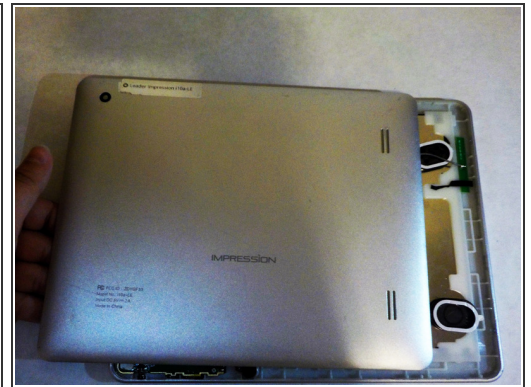
## Step 2

- Start by prying the back off by using plastic opening tools
- Using the plastic tools slide the flat end into the device.
- Gently pry the back piece until you hear a popping noise.
- Once the back is loose, remove it from the device and set aside.
